The influence of hydrothermal aging on E-glass and S-glass fiber/epoxyreinforced composite pipes

This research examines the consequences of low-velocity impact loadings and distilled water ageing on E-glass and S-glass fiber-epoxy reinforced composite pipes that were exposed to internal burst pressure and followed by axial compression. The composite pipes, which comprised of four defiant symmetric layers with $(\pm 55^\circ)^3$ winding angles, were produced by the filament winding procedure. The samples were reduced from the pipes to the required experimental length. The samples were then immersed in 90 °C water for the time period intermissions of 600, 1200, and 1800h. The impact heaps of three various dissimilar energy intensities (7.5 J, 10J, and 12.5 J) were employed and pursued by monotonic internal burst pressure and axial compression tests. SEM pictures were taken and the relationship between the ageing period and the point of impact of the composite pipes was identified. The results show that the internal burst pressure failures are contingent to the applied impact energies. Finally, it can be concluded that the burst pressure and the compression behaviours of the conditio

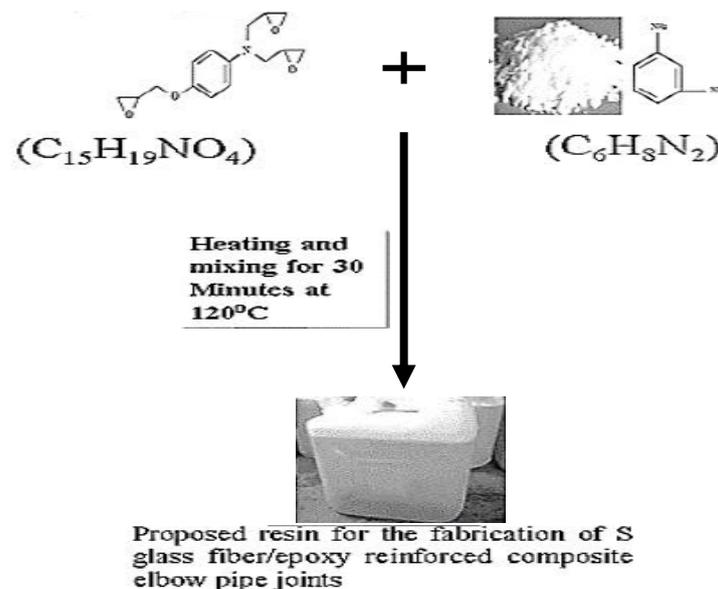
Figure 1: Preparation of proposed resin for the fabrication of the S- glass fiber/epoxy composite pipes as per ASTM STP 569 Standards [16]

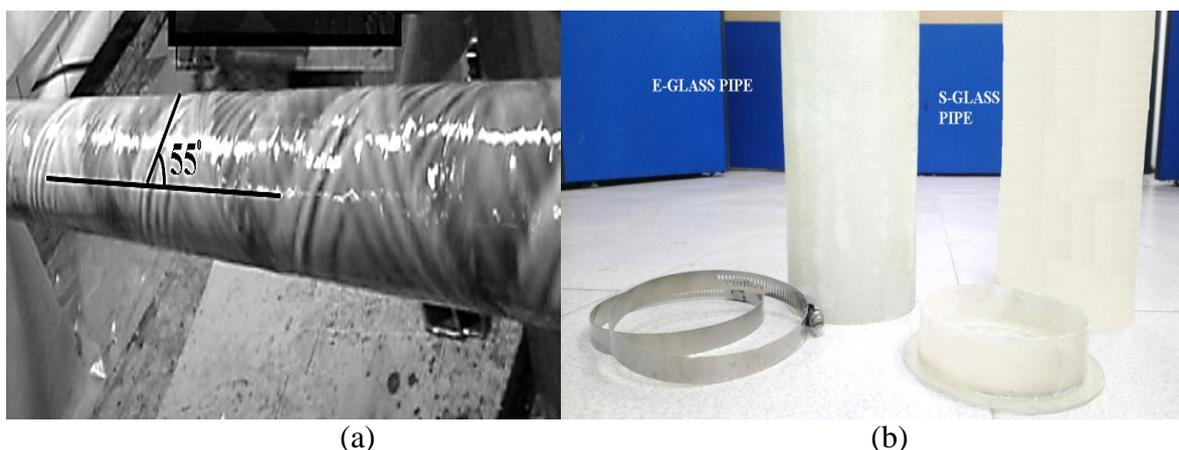
Figure 2: (a) Filament winding process of E-glass and S-glass fiber/epoxy composite pipes. The inset represents winding angle as $\pm 55^\circ$, (b) E-Glass and S-Glass fiber/epoxy composite pipes used for tests

Glass epoxy pipes were manufactured using a controlled filament winding machine with $(\pm 55^\circ)^3$ winding angle. E-glass and S-glass fibres with a density of 1140 tex and a diameter of 18 μm were employed as the reinforcing fabric. An inner radius of 100mm, an outer radius of 101.75mm were used as the dimensions for the fabrication of E-glass and S-glass fiber/epoxy reinforced pipes. Polyester resin ETERSET (2960P-5) and hardener were selected as the matrix for E-glass elbow joint, and in the case of S-Glass elbow joint N-Matrix type resin N,N diglycidyl-4-glycidyoxyaniline ($\text{C}_{15}\text{H}_{19}\text{NO}_4$) supplied by Sigma-Aldrich [17] was cross-linked with meta phenylene diamine ($\text{C}_6\text{H}_8\text{N}_2$) supplied by Zhejiang Amino-Chem Co., Ltd., which is typically used for marine applications [18] as shown in Figure 1 below. The E-Glass and S-Glass elbow pipe joints used for tests and their mechanical properties are presented in Figure 2 and Table-1 below.

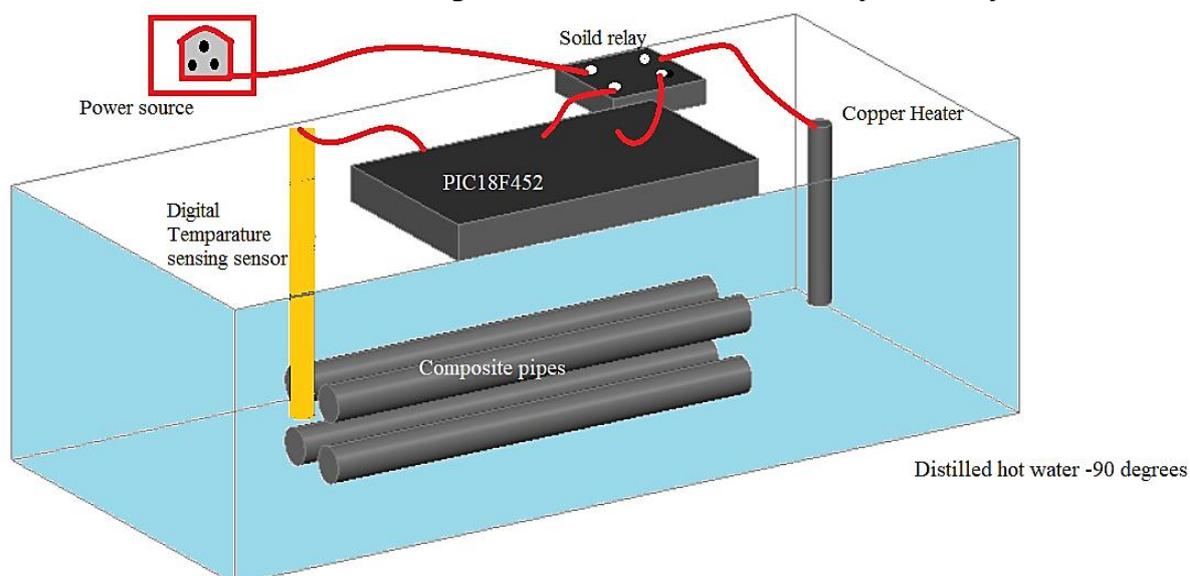
Figure 3: Diagrammatic representation of composite pipes under hydrothermal ageing process

The venerable conditions of the E-glass and S-glass fiber reinforced epoxy composite pipes were attained by submerging the pipe samples in normal distilled water for 600, 1200, and 1800 hours in an isolated tank with the dimensions of 44 inches in length, 27 inches in breadth, 31 inches in height and the wall thickness of 2.5mm, as shown in Figure 3. The hydro thermal ageing process was performed until the water reached the utmost diffusion state. Water temperature was sustained at 90 °C to speed up the ageing activity. Temperature in the container was regulated by using a copper immersion heater with the capacity of 4 kW and attached by PIC microcontroller to monitor the temperature. The percentage of absorption of water by the samples was governed in accordance to the ASTM D570 standard [19]. Water engagement was analysed by the weight gained by the immersed samples to the weight of the dry samples. Three glass fiber reinforced epoxy pipes fabricated with E-glass and S-glass fibres were tested. The tank was closed using a lid and fastened on all sides to prevent dispersion of heat.

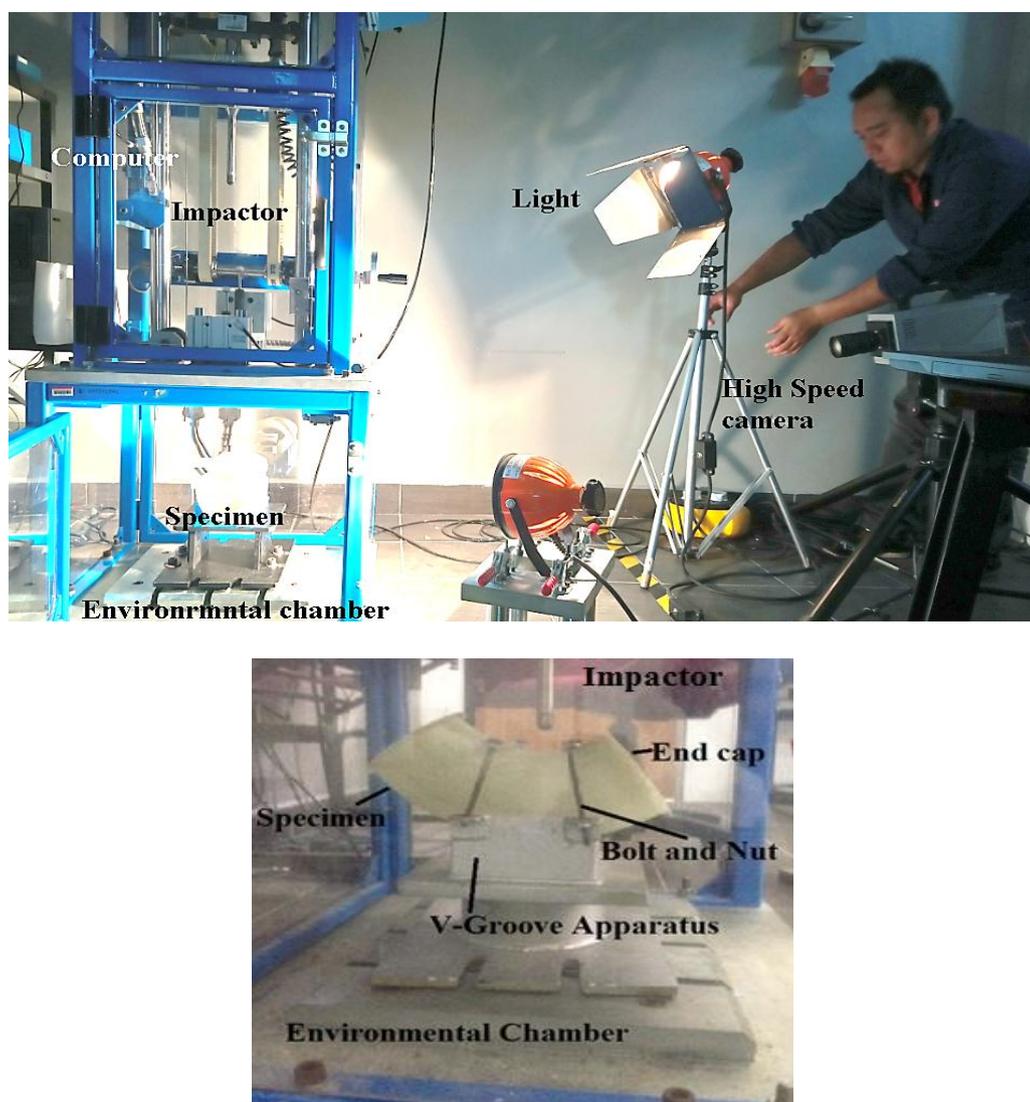
Figure 4: The setup of IMATEK Ltd drop impact testing machine and the test jig used for impact testing.

Typically, impact resistance alongside with impact strength is the most commonly considered property to be calculated to predict the damage in the composites. Impact damage can be prophesied by two methods such as impact damage resistance and damage forbearance. In the present, design impact tests were carried out by utilising a machine corresponding to ASTM D2444 standards [20]. The impact machine can be operated for various functions from high to low impact momentums. The impactor holds a hemispherical nose like structure with 12.5mm diameter, which is installed with a 22.3kN piezoelectric force transducer. The overall falling mass with the crosshead, impactor nose and force transducer was 5.04 kg. While performing the impact tests, a bounding structure was used to control the specimens from various impacts. Experiments were performed with different impact energies of 10J, 15J, and 20 J; in order to examine the damage development in different fiber/epoxy composite pipes at room temperature. For the impact tests, a unique apparatus was designed and developed. The fiber/epoxy composite pipes were closed with two glass epoxy lids to create a real composite pipes situation as shown in Figure 4 below; it was rested on the hollow and secured to the bottom plate of the equipment with four nuts and bolts. A high speed camera with a hotshot SC software was used to predict the contact time between the specimen and the impactor as shown below in Figure 4.

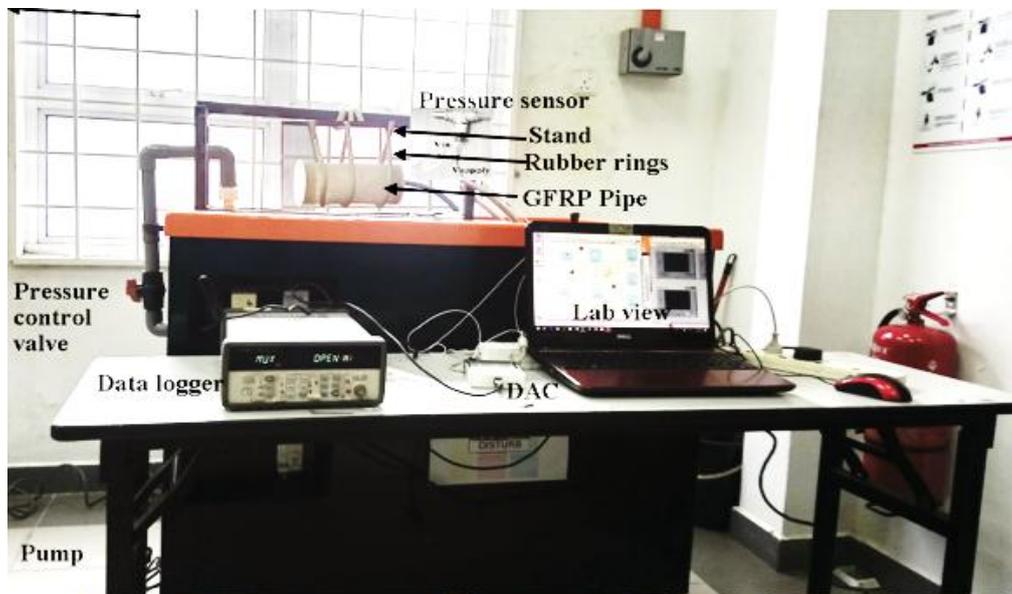
Figure 5: Monotonic burst pressure test rig designed according to ASTM D1599[22]

The quick interval burst pressure tests were implemented with a minimum of four samples corresponding to ASTM D1599 standard [21] as shown in Figure 5 and Figure 6. A built free apparatus was utilized for quick interval hydraulic burst pressure. The equipment permits the composite pipe to contract and to increase in the

diameter liberally which enables the calculation of the axial stress of the composite pipe. The inner pressure was produced by a hydraulic pump. Throughout the investigation, pressure inside the pipe was constantly and evenly increased until failure occurred. Internal pressure test intervals were calculated until the composite sample collapsed to a specific load rate.

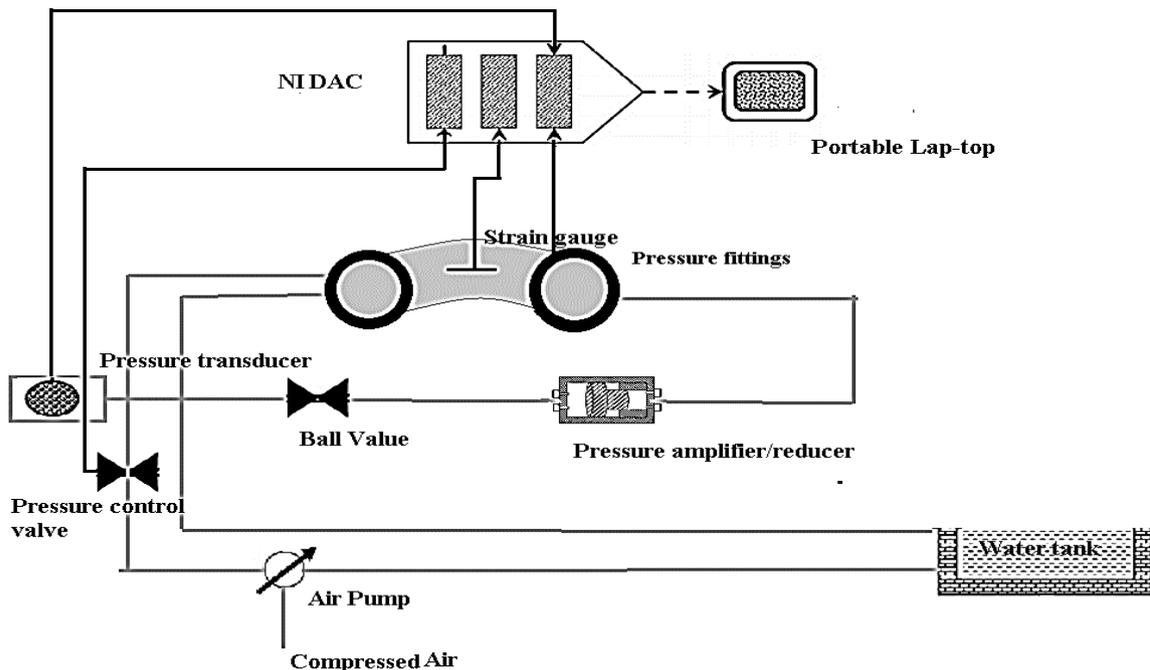
Figure 6: Diagrammatic representation of the automated pressure test rig

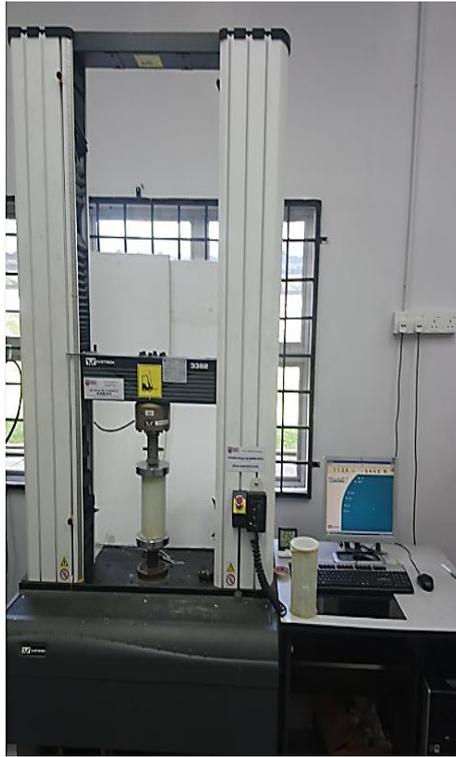
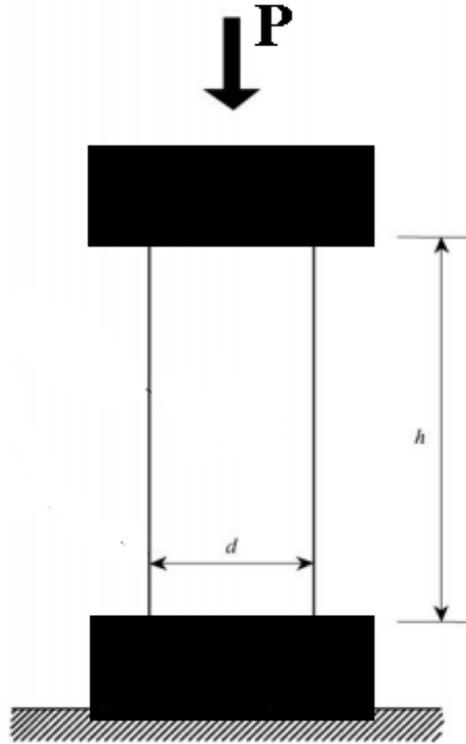
Figure 7: Axial compression test machine with closely fitted pipe with epoxy lids and the process of applying axial load

Compression tests after impact and internal pressure tests were conducted by employing an INSTRON-1195, which has a capacity of 500 kN as per ASTM D695 – 15 Standard [22] as shown in Figure 6. The samples were subjected to loading at a constant cross-head speed of 2.5 mm/min. The elbow pipe joint was compressed axially using two plates with a fixed size. Based on the present work, the Glass Fiber/epoxy Composite elbow joints were subjected to axial compression tests until failure occurred at the contact point between the both ends of the pipe and the compression plates of the test machine.

The main problem during the compression test is the failure formed at the end of the pipe that was the contact point between the tube ends and the plates of the compression test machine. This failure occurred before obtaining the real compression strength of the pipes. To prevent the sample from this premature failure, the tubes were closed with two glass–epoxy lids at both ends, as shown in Figure 7. In the compression tests, a data acquisition system records the axial force –strain history.

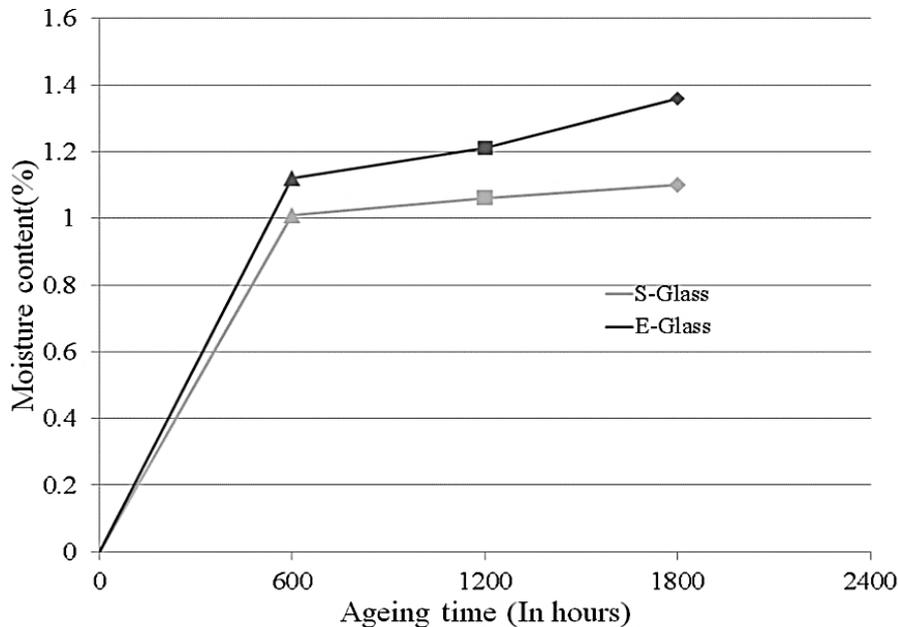
Figure 8: Comparison of moisture content versus hydrothermal ageing time in hours of E-glass and S-glass fiber/epoxy reinforced composite pipes.

The fiber/epoxy bonding became flexible with the increase in the hydro water immersion time owing to the higher amount of water absorbed by the composite pipes. This phenomenon caused the E-Glass and S-Glass fiber laminates to soften and the fiber–polyester resin bond to further degrade; since the matrix became pliable owing

to the occurrence of plasticisation [1, 23]. The impact and strength performance of these pipes can be effected by this condition of ageing. As the immersion period increased, the quantity of water molecules existing increased with the decrease in the polyester resin contents and finally resulting in higher possibility of interlaminar shear strength reduction. The stress transmission ability of the composite pipe, however, stays more at lower immersion time due to fiber/resin bond. Comparison of moisture content and hydrothermal ageing time period in hours of E-glass and S-glass fiber/epoxy reinforced composite pipes is shown above in Figure 8.

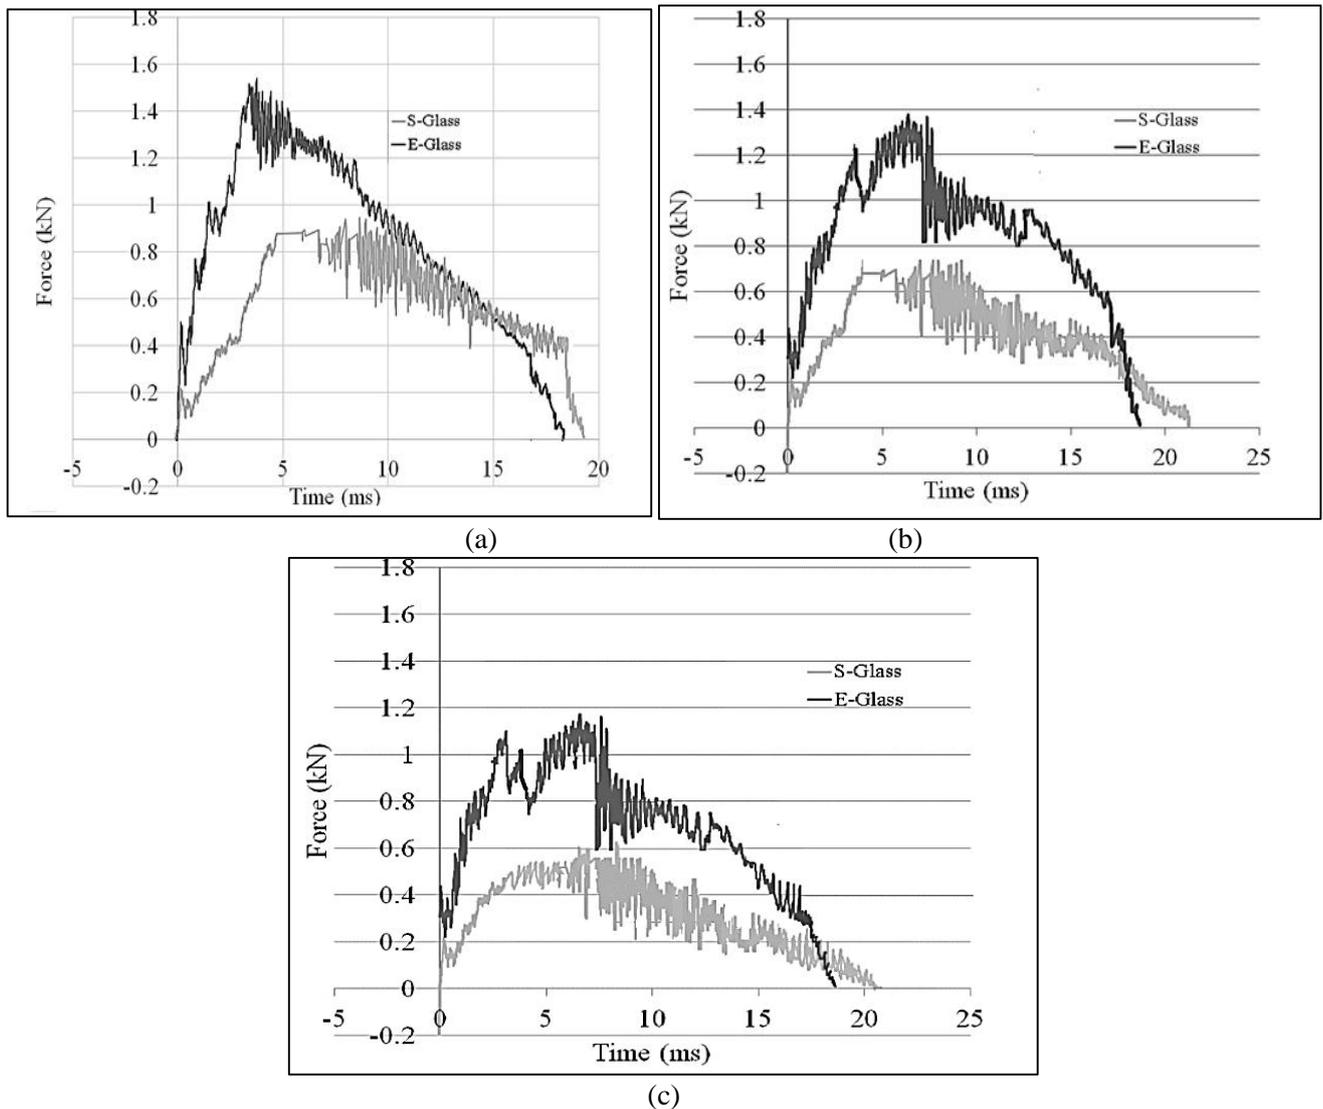
Figure 9: A comparison of force and ageing time of S-glass and E-glass fiber/epoxy reinforced composite pipes at (a) 7.5J, (b) 10J and (c) 12.5J

Figure.9 above projects the force and ageing time graphs of two different materials with three different impact energy levels under un-aged condition. One additional point that can be noticed from the graphs is that for each single level of impact energy, the force decreases with the decrease of aging/immersion time period. The maximum force is more prominent in the case of composite pipe fabricated with E-glass rather than S-glass, and this is similar in the case of aged and un-aged. The ultimate force is extreme in the case of un-matured samples and it reduces progressively with an upsurge in the immersion time period from 600 h to 1800 h. Ultimate forces are recorded for the 1200-h- and 1800-haged samples because of the plasticisation of the matrix

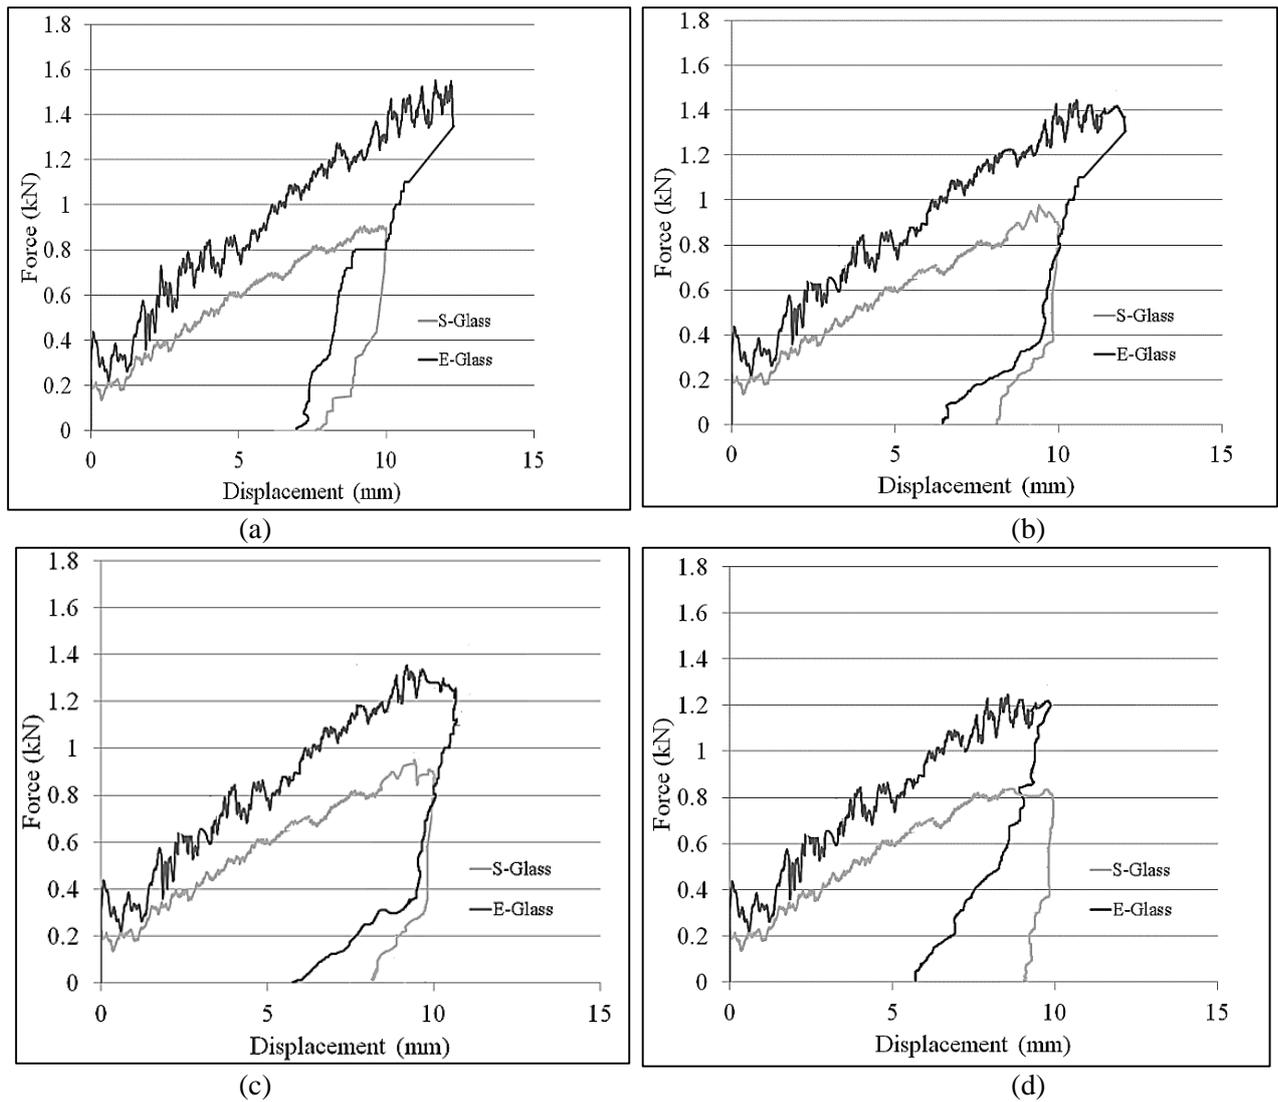
Figure 10: Force–displacement curves with 7.5 J impact energy: (a) dry sample and samples aged for (b) 600 h, (c) 1200 h, and (d) 1800 h

Another significant factor for evaluating the impact characterisation of E-glass and S-glass glass fiber/epoxy composite pipes is the utmost displacement. In an impact test, displacement can be defined as the progress of impact on the pipe exterior surface from the normal state to the impacted state. Figure.10-12 display the displacement to force graph of the impact on tested pipes for all circumstances. Based on the graph, it can be

clearly observed that the displacement surges steadily with the rise in the impact energy for the mature composite pipes. The displacement also amplifies from the E-glass and S-glass glass fiber/epoxy composite pipes which are under dry condition to the 600 hour immersed samples before declining progressively following ageing for 1200 hours. The area below the force and displacement graph denotes that the energy was dispersed due to plastic distortion. The absorbed energy can be calculated mathematically by observing the consequences attained from the force and displacement graphs by means of the subsequent Eq. (4):

As can be seen from the above Figures.10-12, the E-glass fiber/epoxy composite pipes at 1800-h- immersion time generally absorbed lesser energy than the S-glass glass fiber/epoxy composite pipes. It can be concluded that the energy absorption on the composite pipe build-ups depends on the energy dispersed by the damaged part. Figure 13 shows an image of the damage that occurred in the vicinity of the impact point of the E-glass and S-glass glass fiber/epoxy composite pipes. The damaged area increased in size with the increase of the impact energy and ageing time.

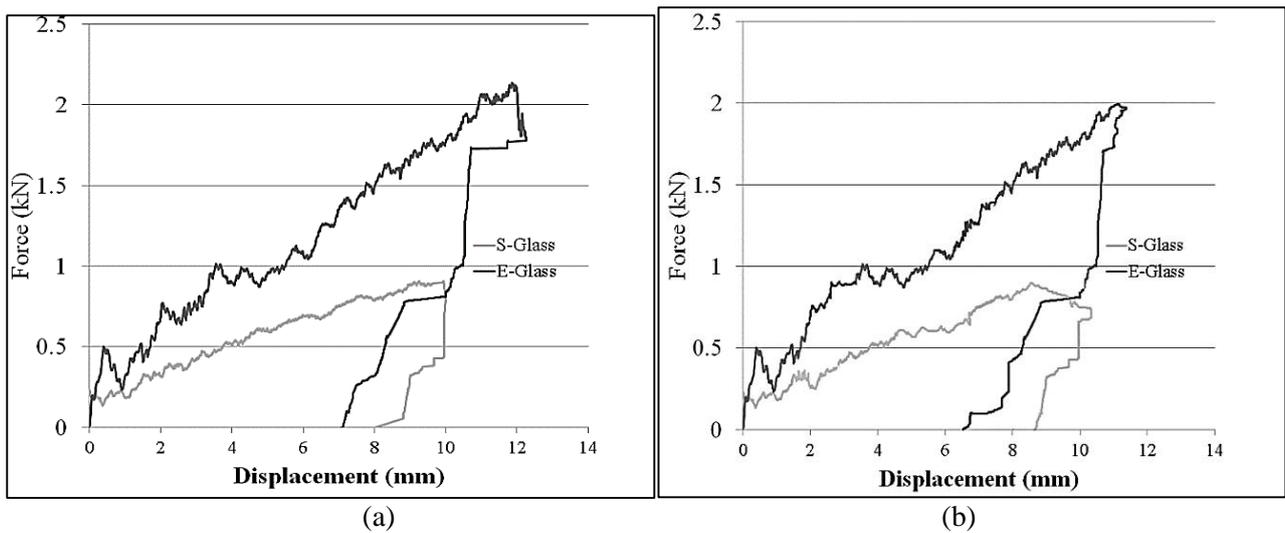
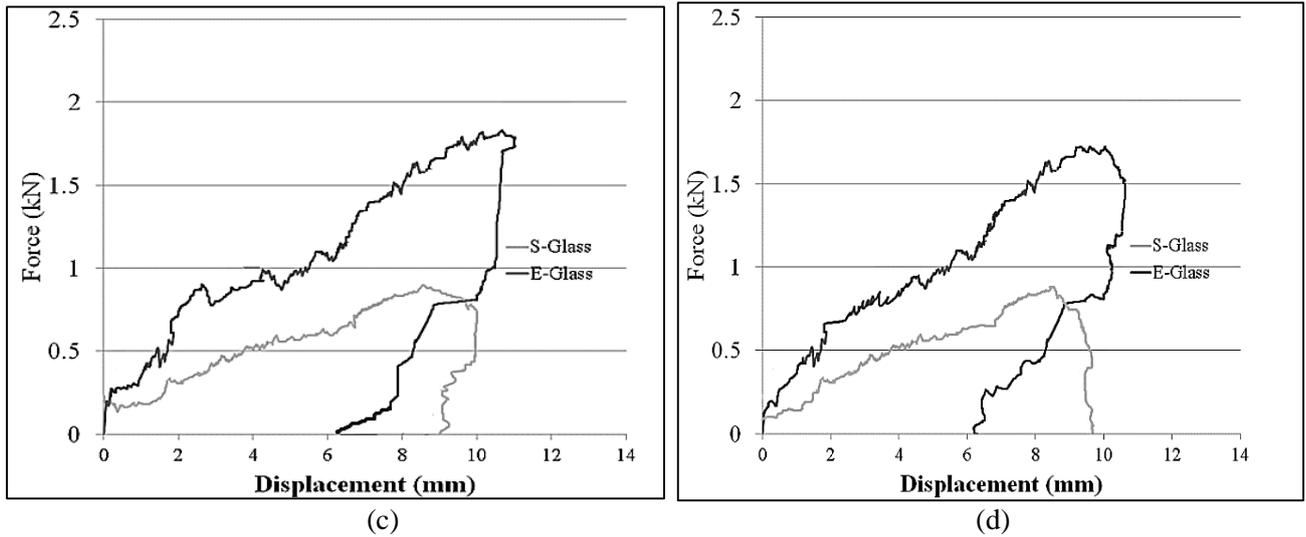
Figure 11: Force–displacement curves with 10 J impact energy: (a) dry sample and samples aged for (b) 600 h, (c) 1200 h, and (d) 1800 h

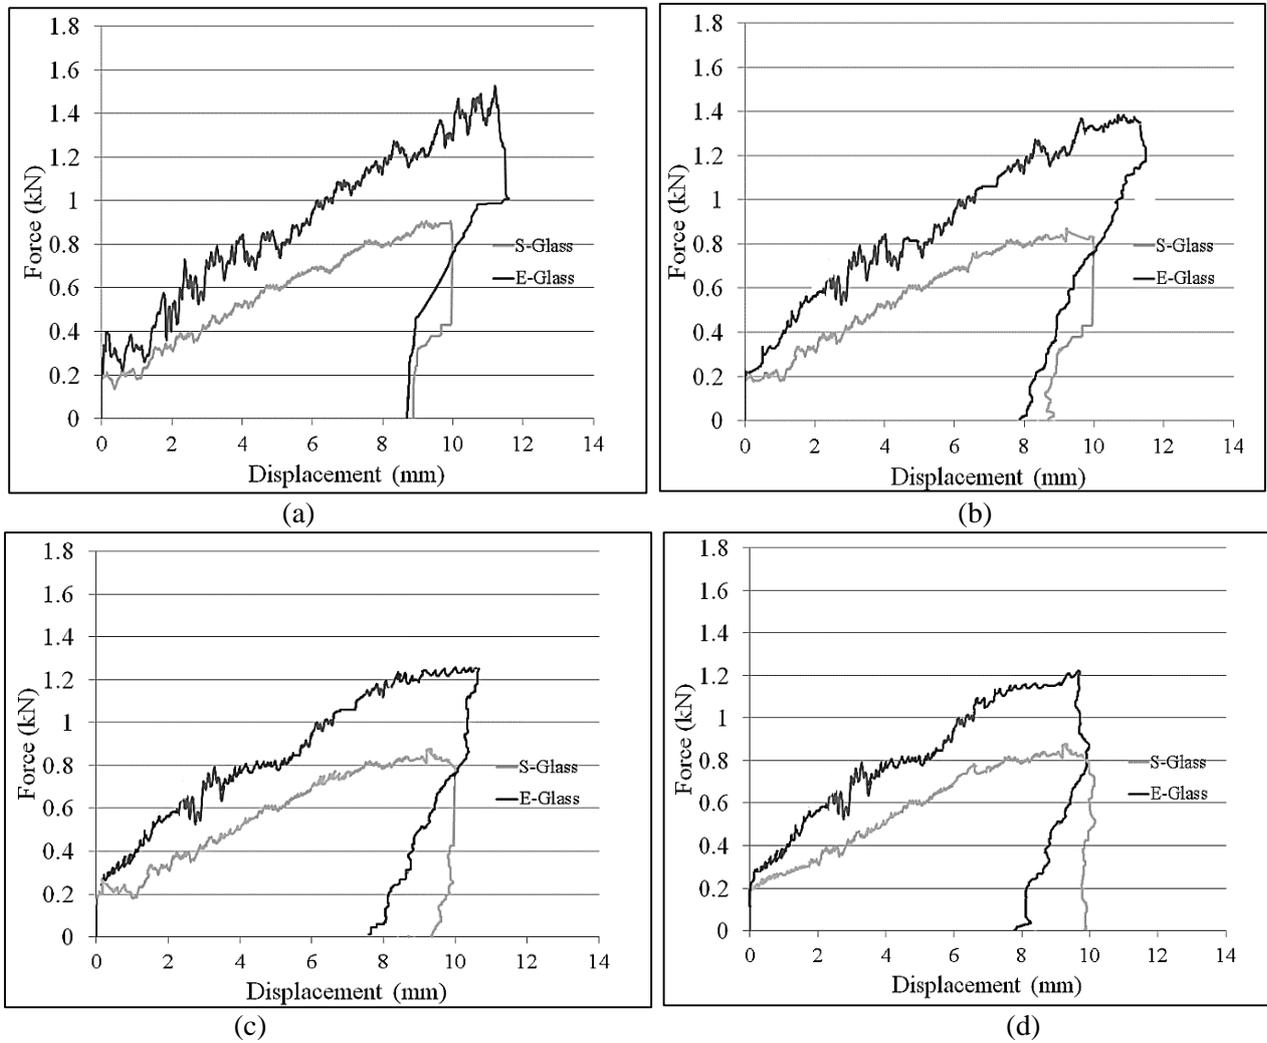
Figure 12: Force–displacement curves with 12.5 J impact energy: (a) dry samples and samples aged for (b) 600 h, (c) 1200 h, and (d) 1800 h

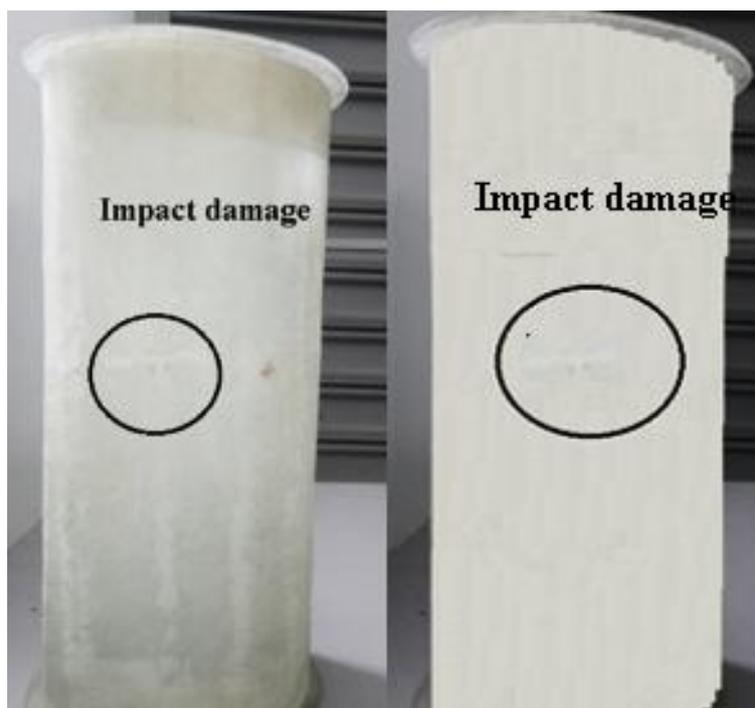
Figure 13: *Damage views of glass fiber /epoxy composite pipe (a) E-Glass (b) S-Glass with a sample impact energy*

Based on thorough examination, two damages were noticed on the E-glass and S-glass glass fiber/epoxy composite pipes. Fiber/epoxy interface cracking and delamination occurred more on the pipes impacted with 10J and 12.5, but when it came to the point of 7.5 impact damage, only fiber/epoxy inference cracking can be noticed. For the types of material, E-glass composite pipes suffered both matrix cracking and delamination when subjected to 7.5j impact, but in the case of S-glass composite pipe, the damages were observed eventually). The filament wounded S-glass composite pipes showed higher elongation and stiffness to withstand maximum load in all cases, when compared to E-glass composite pipes. Glass fiber rupture and perforation of the impactor were noticed during the tests in the case of E-glass fiber composite pipes for the preferred impact energy intensities.

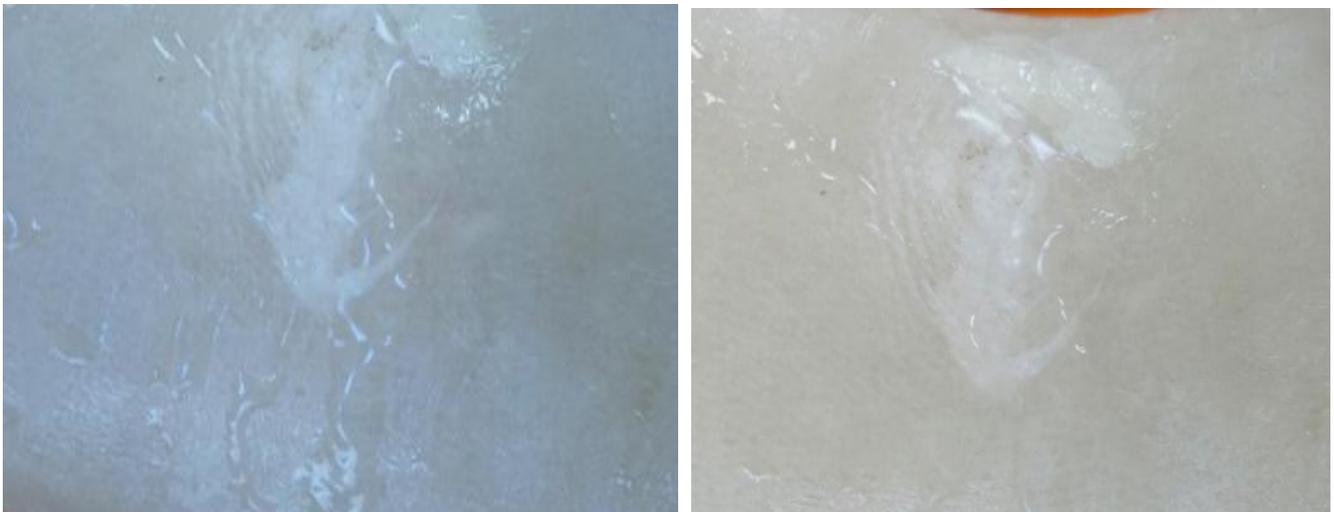
Figure 14: Water leakage at maximum pressure in E-glass fiber/epoxy composite pipes and S-glass fiber/epoxy composite pipes

5. Three damage stages were noticed from the internal burst pressure tests; initially as the internal pressure increased, whitening patch was followed by the occurrence of weepage and eruption let-down.

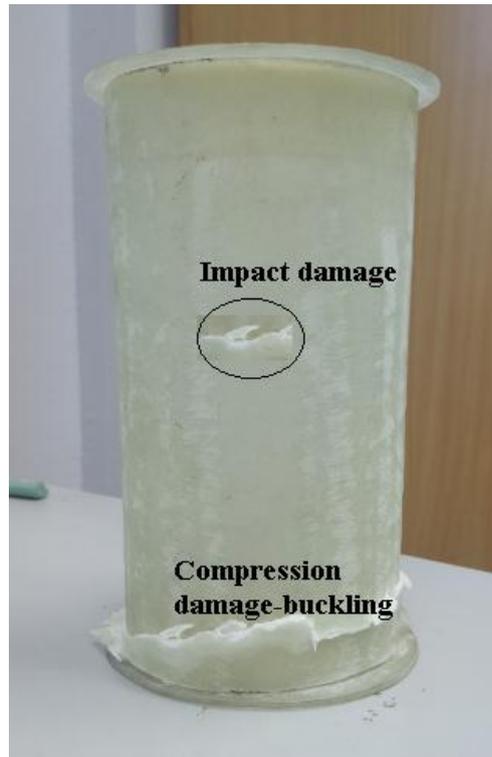
Figure 15: Compression damage and buckling damage in a sample E-glass fiber/epoxy composite pipe

Figure 15 shows a photo of the E-glass glass fiber/epoxy composite pipe subjected to compressive loading after impact and burst pressure tests. As can be seen from Figure 15, damages generally occur near the end of the composite pipes due to the local buckling behaviour, especially in the composite pipes fabricated with E-glass fiber. The failure generally propagates from the impact point, except for the specimens made of S-glass fiber. For these pipes, the failure is likely to be resulted from buckling due to the elastic nature of the fiber. The variation of compression-after impact and burst strength of the composite pipes are obtained according to the type of material

and the impact energy levels. Compressive strength does not change significantly for the S- glass specimens; however, in the case of specimens that are fabricated with E-glass, the strength drops suddenly because of buckling.

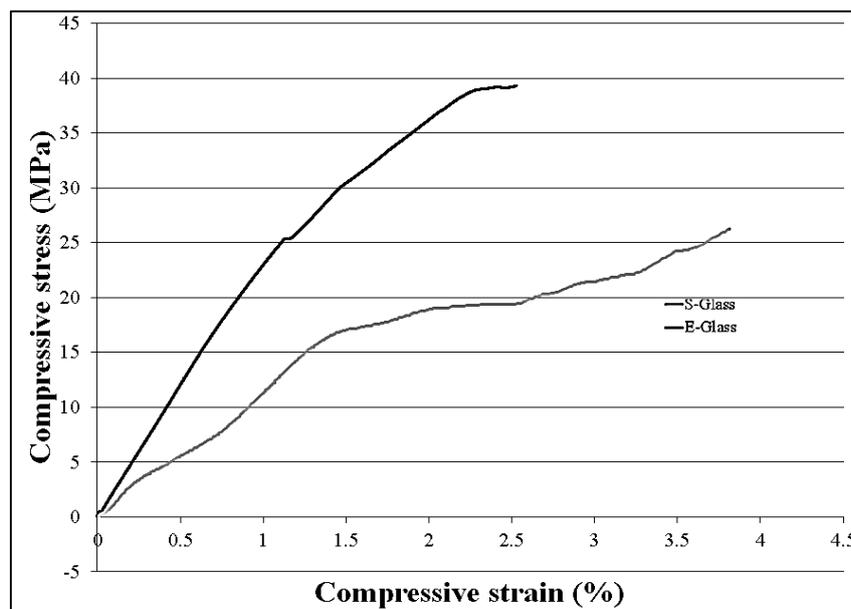
Figure 16: Compressive stress versus compressive strain of E-glass fiber/epoxy composite pipe and S-glass fiber/epoxy composite pipe

Finally, Figure 16 shows that there is no serious damage on the E-glass and S-glass glass fiber/epoxy composite pipes. However, on the part of impact damage zone, the main failure mode seems to be of buckling. Also, it is observed that the axial compression-after impact- burst pressure strength increases or decreases with the parameters such as impact energy, internal burst pressure, material and matrix used
