Earth Masonries in the Medieval Grange of Cuna – Siena (Italy)

Abstract

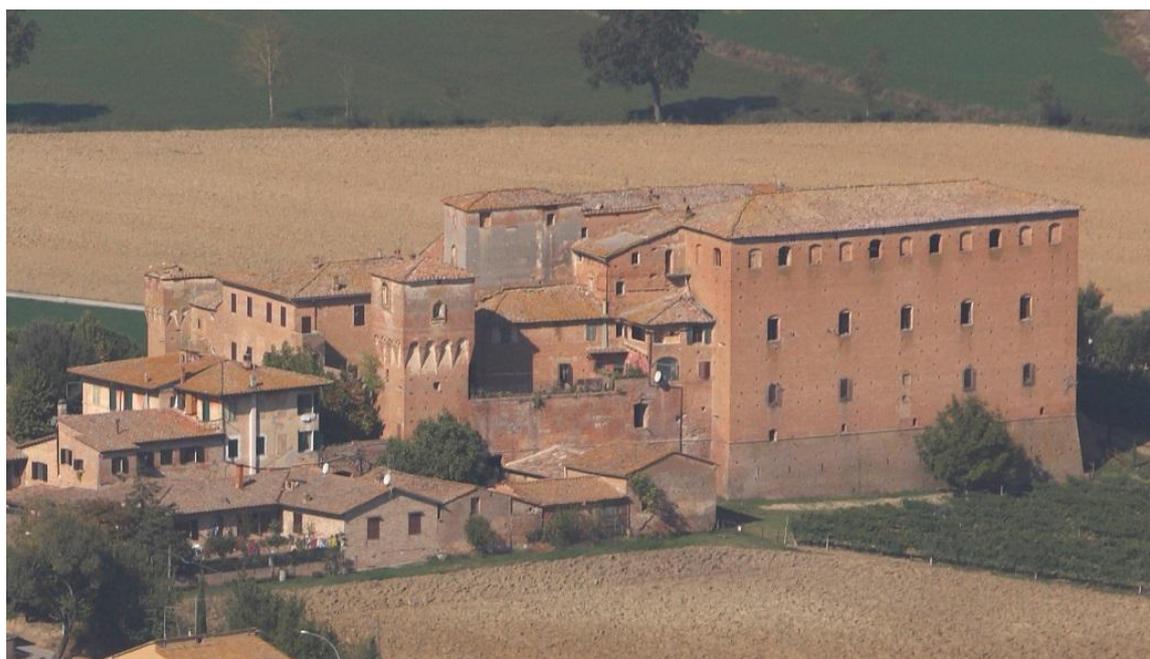
Figure 1: Aerial view of the Grange of Cuna. The big building on the right is the granary (after D'Andria et al., 2015, modified).

The brick complex consists of a small village surrounded by walls with gates and towers; the current farm develops within the village, with the imposing structure of the granaries accessed by a partly covered ramp (Figure 1). For its extraordinary state of preservation, its size and the internal organization of several buildings,

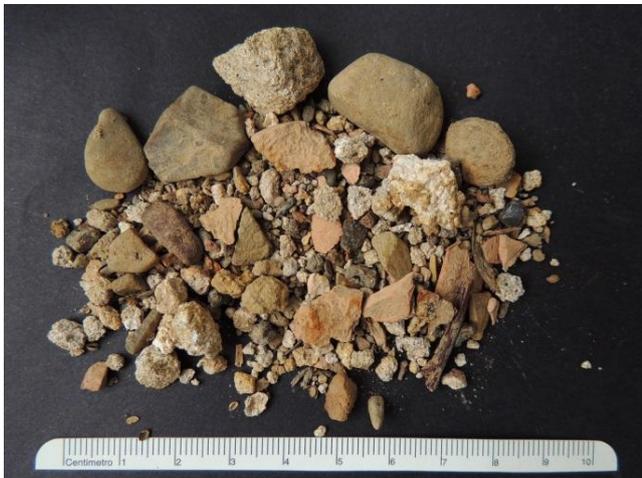
Figure 4: Pebbles and fragments of mortar, terracotta and wood in the rammed earth masonry of the wall D (PI500)

As pointed out above, in the coarser fraction, a considerable amount of reemployed material like bricks and mortar fragments (see further) is also present (Figure 4). It is worth noting that the rammed earth wall E, found at the ground floor very near to the D wall, contains far less mortar additions. The fraction $< 4 \mu\text{m}$ shows the presence of illite, kaolinite, chlorite-vermiculite, illite-smectite and vermiculite in all the samples.
