Wear Performance of Thermally Sprayed NiCrBSi and NiCrBSi-WC Coatings Under Two Different Wear Modes

R. Rachidi^{1*}, B. El Kihel¹, F. Delaunois², V. Vitry², D. Deschuyteneer³

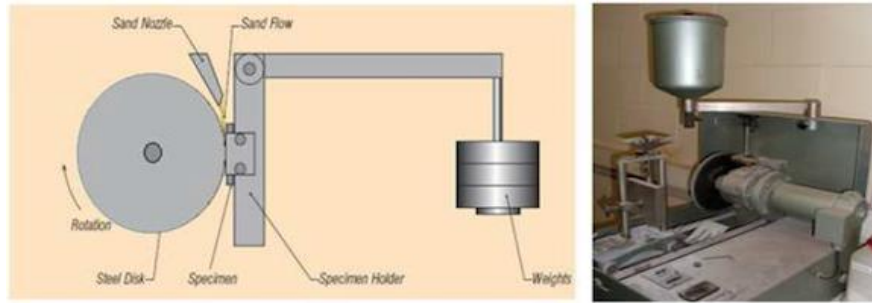
Figure 1: Schema (left) and equipment (right) of the sand/wheel wear test [19].

Two different wear tests were conducted as part of this work in Belgian Ceramic Research Centre (Mons, Belgium). It is important to note that these tests are carried out without any lubrication to study the wear behaviour under severe conditions. In addition, all samples have been polished and properly cleaned before performing the tests. In the dry sand/wheel test, the test specimen is pressed against the rotating wheel at a specified force by means of a lever arm while a controlled flow of grid abrades the test surface. The rotation of the wheel is such that its contact face moves in the direction of the sand flow [19]. Figure 1 shows the sand/wheel wear test set-up. The test was carried out at room temperature (about 20 °C) under a load of 30N for a constant duration of 16 min for each test, which corresponds to 20000 revolutions at constant wheel rotation speed (1250 t/min). The flow rate of abrasive particles (Al_2O_3) was between 300 and 400 g/min. The volume loss of coating material that presents the resistance to wear was calculated theoretically from the length of the wear track measured after the test using a 3D digital microscope. Ten profiles of the wear track being made, from the first edge of the wear track to the second, and then calculate an average value of the wear track length. The worn volume is calculated according to the formula [18]:

$$V = \left(\frac{\pi \cdot \alpha}{180} - \sin \alpha \right) \frac{hd^2}{8}$$

$$\sin(0,5\alpha) = \frac{L}{d}$$

where V is the volume loss [mm^3], h is the thickness of rotating disc [mm] (10 mm), d is the diameter of rotation disc [mm], α is the angle in degrees and L is the impression length measured [mm].

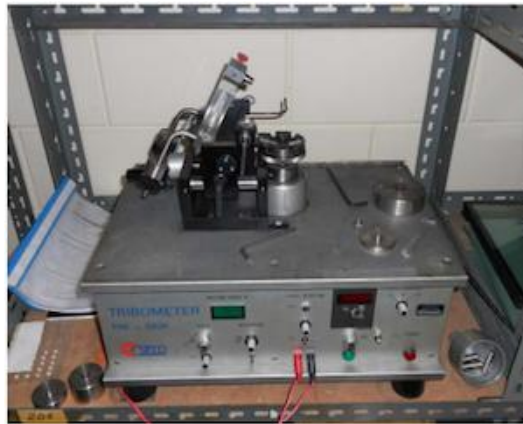
Figure 2: Equipment of pin-on-disc test (CRIBC) [19].

The pin-on-disc test is a method for analysing a material wear and the friction coefficient between two materials. In this work, a pin-on-disc tribometer (Figure 2) was used under a normal load of 10N, a sliding speed of 0.1 m/s and using an alumina pin (Al_2O_3) with a diameter of 8 mm [19]. The volume loss was calculated theoretically; it was not measured by profilometry given the amount of debris accumulated in the groove. The volume loss was therefore calculated from the width measurements of the grooves for each sample using 3D digital microscope.

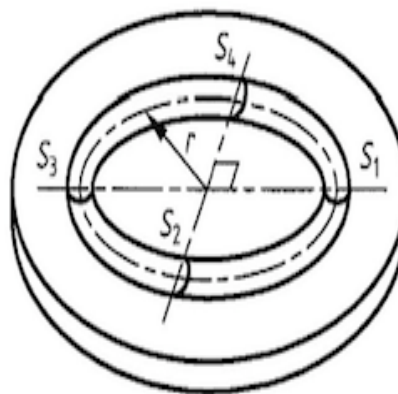
Figure 3: Circular wear track on the disc [20].

where V_{disc} is the wear volume of the disc [mm^3], r is the wear track radius [mm], S_1 to S_4 are the wear track area taken at 4 different locations (as shown in Figure 3) [mm^2].

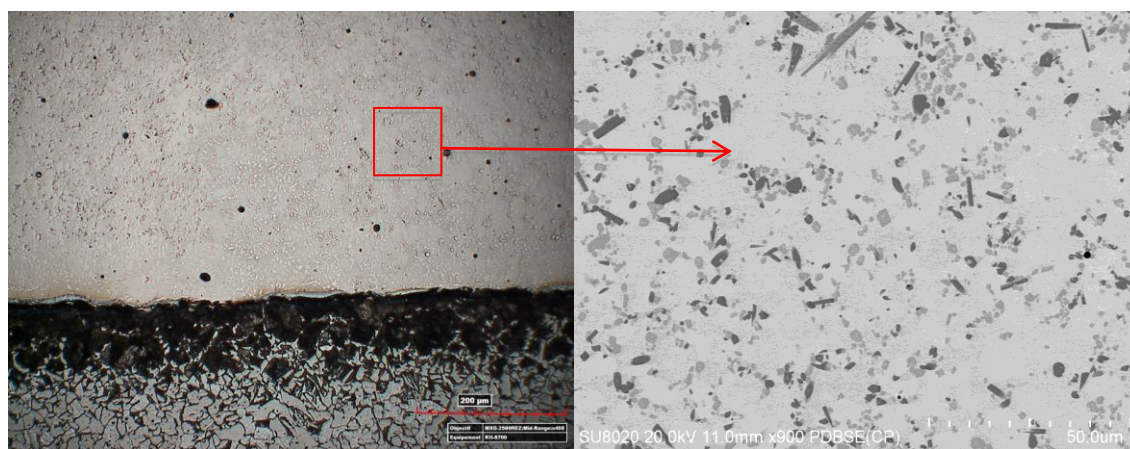
Figure 4: Micrograph of flame thermal sprayed NiCrBSi coating obtained by optical microscopy (left) and SEM (right).

Figure 4 shows the micrograph of flame thermal sprayed NiCrBSi coating obtained by optical microscopy and SEM. Regarding the microstructure, it is clear that coating does not clearly reveal a lamellar structure as shown in literature relative to thermal spray coatings. As global view of coating cross section, the presence of certain level of porosity was observed but was not too pronounced. However, no cracking was observed. According to literature [21], impact temperature and velocity of particles, among other parameters, governing the spreading degree of the splats forming the deposit. Low particle velocity characteristic of flame thermal spraying process ensures that some particles are not well spread at the time of impact on the substrate and therefore, this phenomenon promotes the presence of porosity in coating. Figure 5 shows the micrograph of flame thermal sprayed NiCrBSi coating reinforced with tungsten carbide. As we can see, layer structure is modified by adding WC particles but remains homogeneous. The thermal sprayed composites are composed of matrix and a second phase known as reinforcement, which is WC in our study. WC particles are easily identifiable by their different color and angular shape; they have kept the same shape as in initial powder. Reinforced NiCrBSi coating has a similar level of porosity to that of single NiCrBSi coating with presence of microcracks in the matrix and tungsten carbide particles. These defects are typical of coatings produced by thermal spraying.

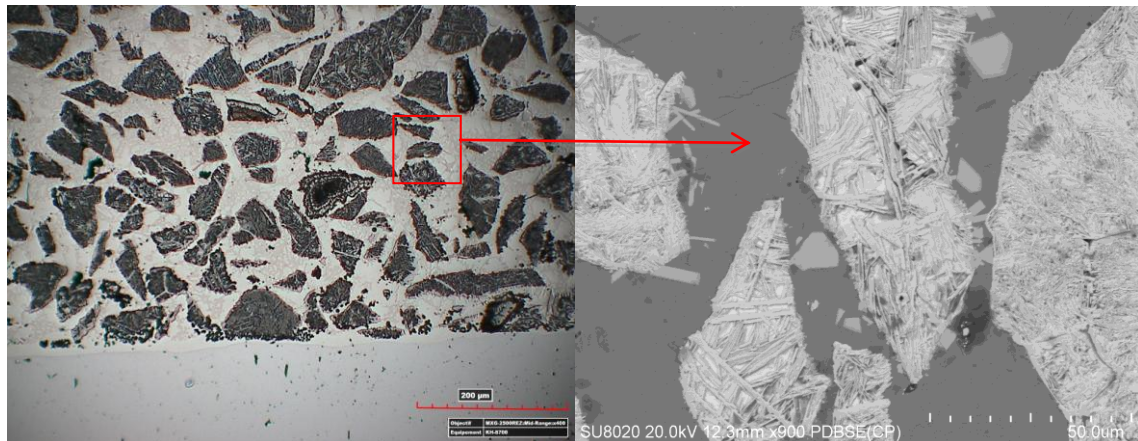
Figure 5: Micrograph of flame thermal sprayed NiCrBSi coating reinforced with WC, obtained by optical microscopy (left) and SEM (right).

The Ni-based matrix contains Nickel, Chromium, Iron, Silicon and Boron. Binary phase diagrams such as NiCr, NiB, and NiSi provide information on the effects of individual alloying elements on the melting temperature of NiCrBSi alloy [22]. They show that the presence of Cr, Si and B elements reduce the melting temperature point of nickel. Furthermore, these three elements play a role in forming hard borides and carbides, owing to improve the mechanical properties of the produced coating. The NiCrBSi is made of a Ni-rich solid solution phase γ -Ni and low content of Ni-Ni₃B eutectic [7]. When the spraying alloy solidified from high temperature, several possible borides, carbides and silicates may be created, such as, Ni₂B, CrB, Ni₅Si₃, Ni₁₃Si₁₂, Ni₃Si, (Cr,Fe)₇C₃ and Cr₂₃C₆. Which one is produced depends to a large extent on the composition of the alloy and the solidification process. Based on the XRD analyses, the NiCrBSi coating was mainly composed by γ -Ni, CrB and Ni₃B phases. With regard to the XRD results and the microstructure of NiCrBSi coating, the dark gray phase is chromium boride CrB, while the light phases can be identified as the γ -Ni solution and Ni₃B. The XRD

analysis of the composite coating confirms the presence of WC, γ -Ni solid solution and a small amount of Ni_3B phase in the coating. Other precipitates such as W_2C and Cr_7C_3 were found in the WC composite coating matrix. These phase compositions are in accord with those reported in literature.

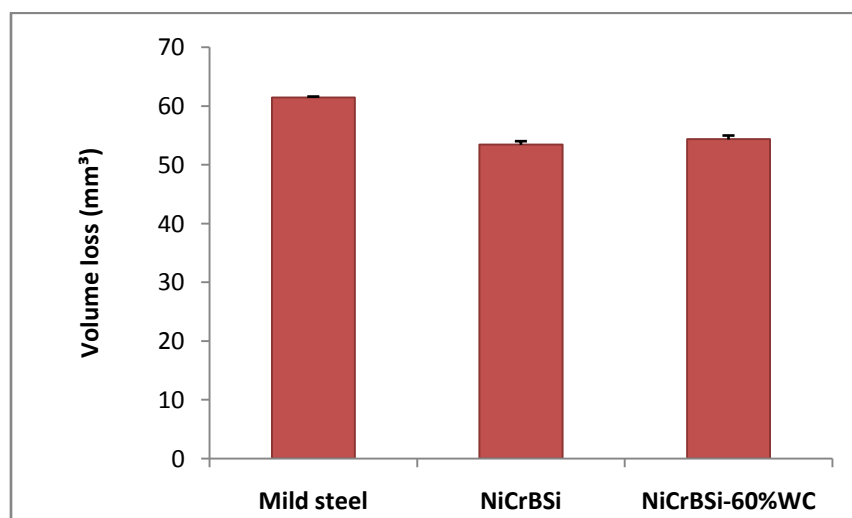
Figure 6: Results of sand/wheel wear test for different used materials.

Figure 6 illustrates the results of the wear resistance achieved with the sand/wheel test (after 20000 revolutions of the wheel). This result is the evolution of the material loss volume during the test depending on studied materials (at room temperature).

- The wear resistance is improved thanks to NiCrBSi layer. The lost material volume has been decreasing by 61 mm³ for the steel substrate to 53 mm³ for the metal matrix.
- The best abrasive wear resistance is that shown by the metal matrix. Unusually, the composite layer made from the powder with 40%NiCrBSi-60%WC revealed lower wear-resistance than the NiCrBSi matrix.

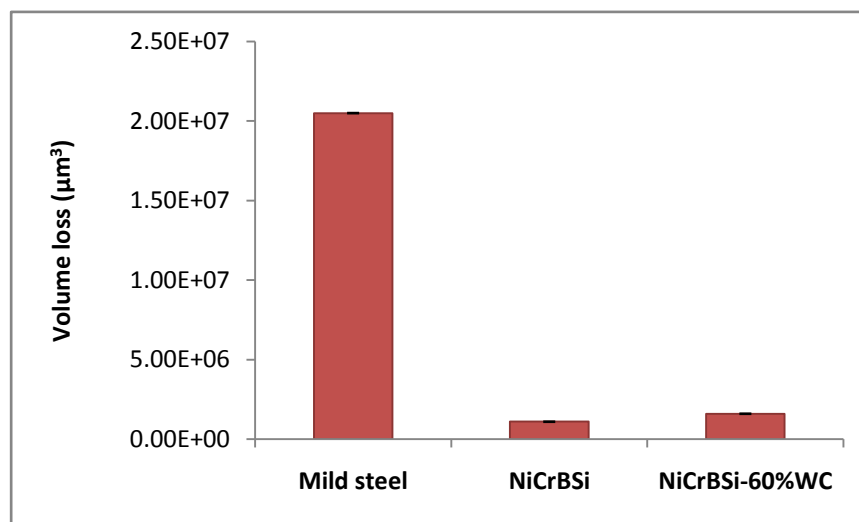
Figure 7: Results of pin-on-disc wear test for different materials.

The pin-on-disc test in continuous motion has been made at room temperature. Wear volumes were then calculated using the model mentioned above. In Figure 7 is shown the volume loss evolution of coating material during the test with the alumina pin, depending on each material. It is clear that the wear rate is widely decreased with the application of coating. The Nickel alloy sample has wear rate less than that of the reinforced Nickel alloy, but remains generally close to that of Nickel alloy. This result is unexpected because, according to the literature, the addition of WC particles should increase the wear resistance.

The results show that the behaviour obtained by pin-on-disc test (abrasive wear) of the three materials (mild steel, NiCrBSi, NiCrBSi-60% WC) is similar to the behaviour obtained by sand/wheel test (erosive wear).

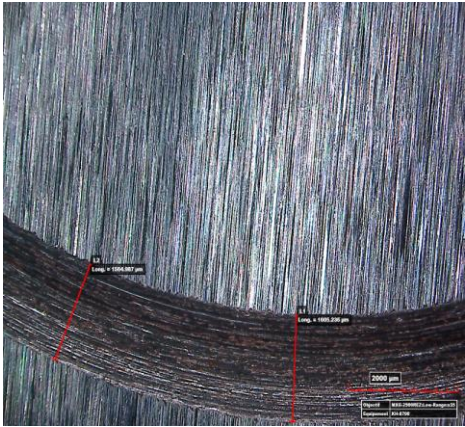
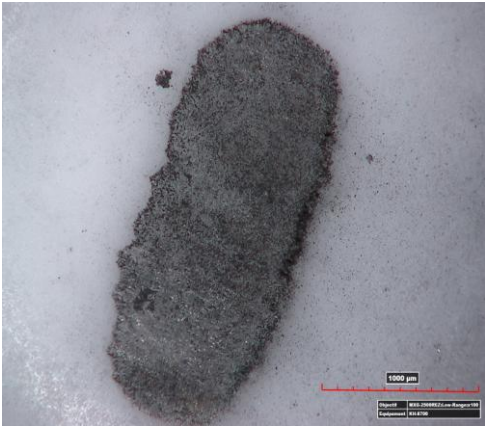
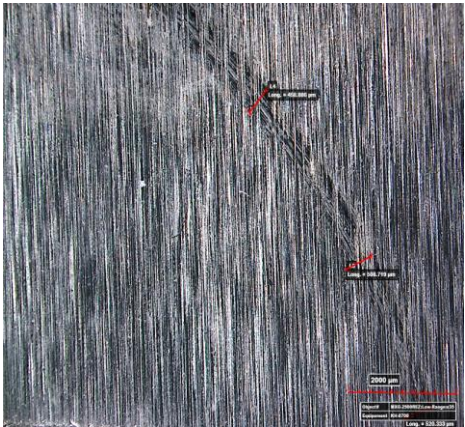
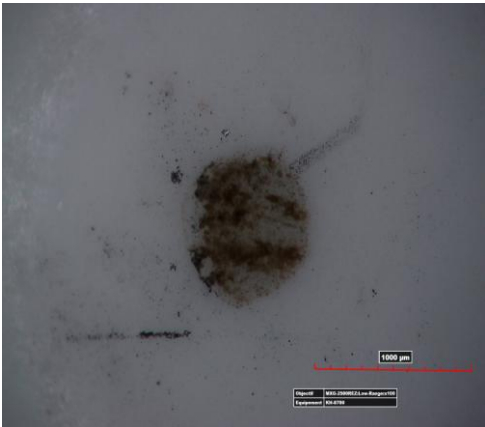
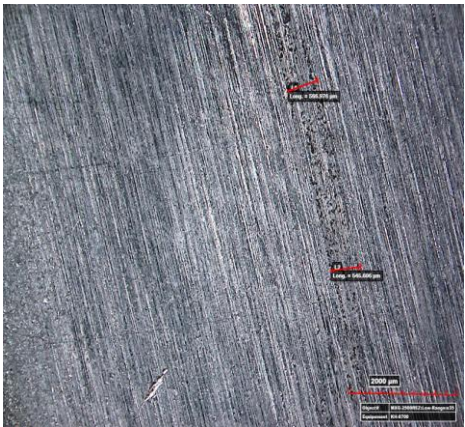
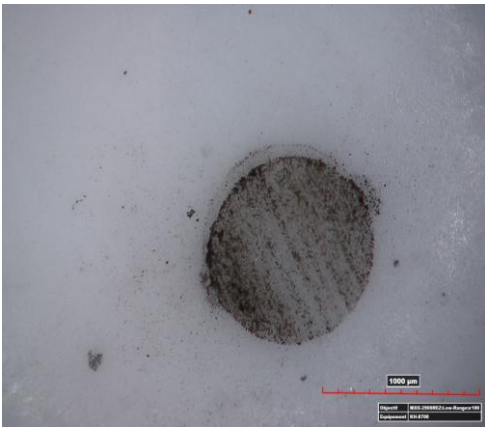
Figure 8: Analysis of wear track for the pin and the different materials after pin-on-disc test.

For this purpose, the grooves were analysed by digital microscopy to determine the volume loss of coating material. During the test, no process has been applied to evacuate the debris that occurring. In contrast, at the end of the test, it is possible that the debris is evacuated at the periphery of the groove as they can be transferred at the friction surface of the counter body. Figure 8 shows the pin's faces and the wear profile of corresponding material after test.

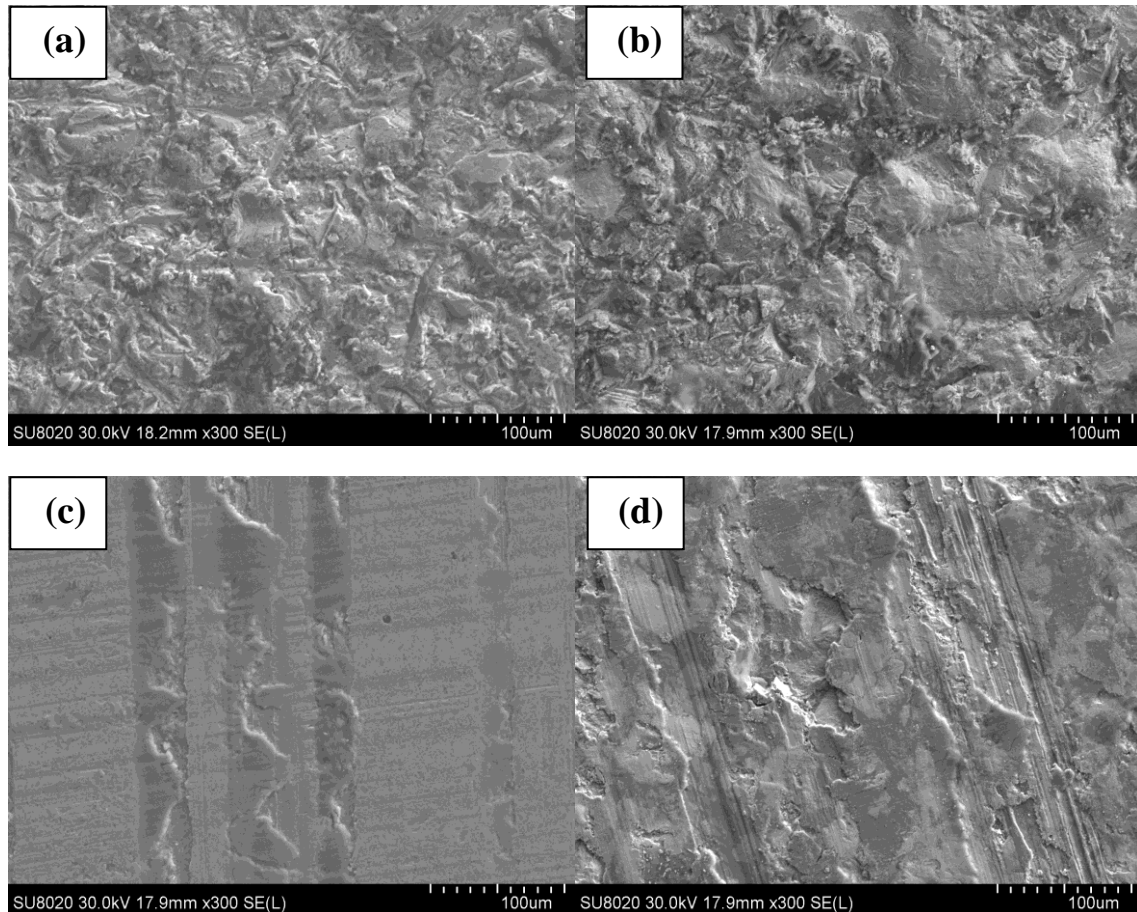
Figure 9: SEM micrographs of worn surface after Sand/Wheel test: (a) NiCrBSi, (b) WC reinforced NiCrBSi and after pin-on-disk test: (c) NiCrBSi, (d) WC reinforced NiCrBSi.

The grooves are formed by many wear track oriented in the wheel's direction of rotation (Figure 9). The same phenomenon is observed for wear track in the case of the sand/wheel test. Observing the wear track on the pin in the case of reinforced coating, it can be noticed that it is greater than in the case of NiCrBSi sample. This may be due to the presence of big content of tungsten carbide particles within the NiCrBSi-60%WC powder, which considerably increases the loss of pin material during testing, while no improvement is observed about the wear resistance of the reinforced coating layer. As indicated in literature review, the concentration of WC plays an important role about the wear resistance. Probably, that the studied concentration of reinforcing particles in this work does not promote the wear resistance of the tested samples.

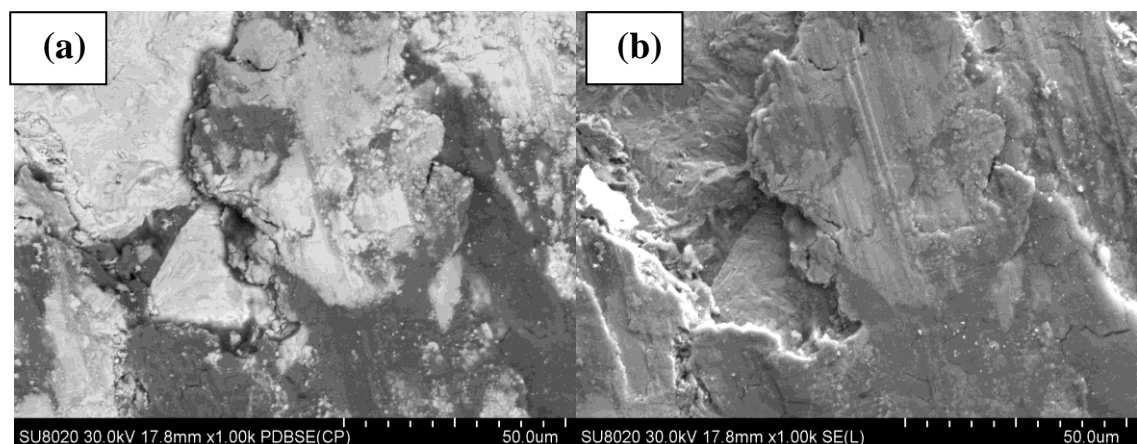
Figure 10: SEM images showed the detachment of WC particles during the pin-on-disc test: (a) SEM-back-scattered electrons and (b) SEM-secondary electrons

This behaviour can be also justified by the detachment of WC particles during the test and can be confirmed by SEM observation of wear track on the reinforced sample (Figure 10). Indeed, the faceted shape of the WC particles enables its geometric boundaries to be defined, and it may be that the connection with the matrix is not too good or has been weakened by the removal of the metal matrix material during test, which promotes the sample detachment more easily. Consequently, an increase in the wear rate is observed. Some similar results have been reported in literature work [6]. Martin et al. [1] suggested that the wear rate of the coating should be considered together with the mass loss rate of the counterbody. At room temperature, the sample is in severe contact with the alumina pin, but as the temperature increases, some particles of the Nickel alloy are transferred to the counterbody, thereby developing a soft layer and reducing the severity of the contact. The abrasiveness of the ceramic WC particles prevents the transfer of material between the sample and the counterbody and therefore the severity of the contact is little changed as the temperature increases. This material transfer of the metal matrix to the pin surface may be the mechanism responsible for the decrease in the volume loss for the

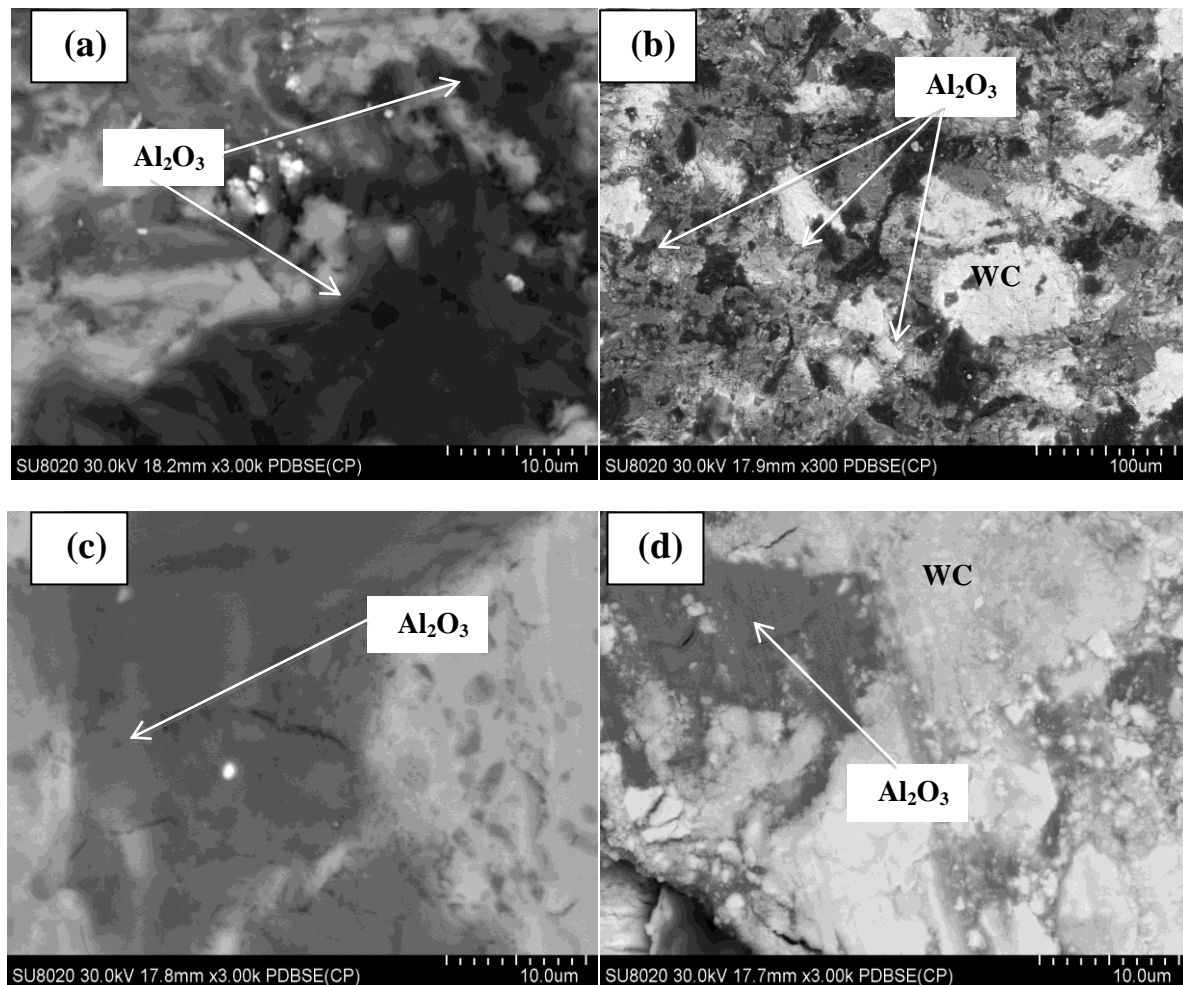
Figure 11: SEM images showed the transfer of Al_2O_3 material from the pin to coating surface: (a) NiCrBSi and (b) WC reinforced for the Sand/Wheel test, (c) NiCrBSi and (d) WC reinforced NiCrBSi for the pin-on-disk test

NiCrBSi sample. However, this mechanism was not confirmed by SEM observation of wear track on the counterbody. Another wear mechanism encountered in literature is the plastic deformation [25]. Furthermore, the counterbody material (Al_2O_3) can be transferred to the coating surface [9], which is confirmed by the SEM observation of the wear tracks as shown in Figure 11.
