The development of a conservation and rehabilitation plan (CRP) for the earthen Kasbah of Taourirt in southern Morocco

M. Boussalh¹, C. Cancino², B. Marcus², L. Wong²

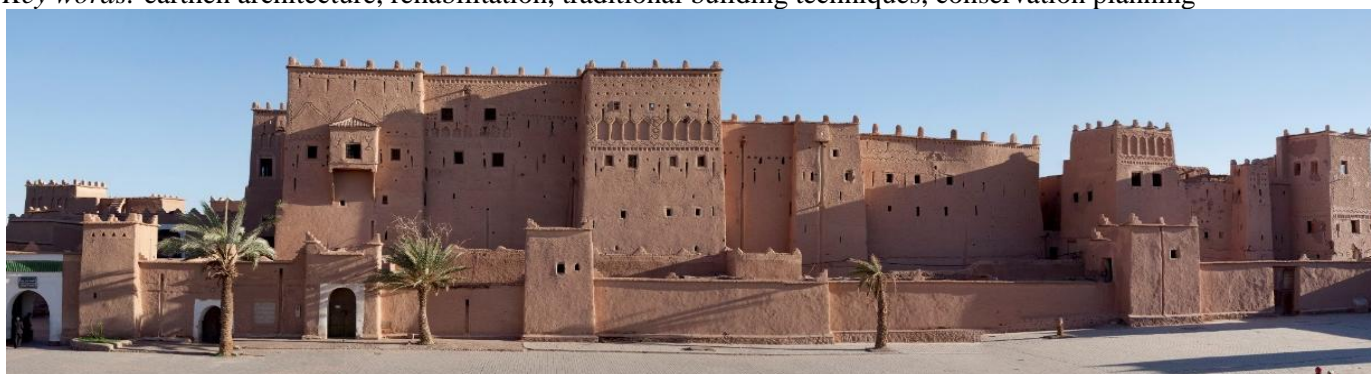
Figure 1 –Kasbah Taourirt, view of the northern façade of the Caid Residence. Photo: Scott Warren, 2014.

Kasbah Taourirt (Fig. 1) is located in the city of Ouarzazate at an elevation of 1,160 meters in the middle of a plateau south of the High Atlas Mountains. The kasbah encompasses nearly 12,000 square meters spread over a low ridge and is composed of various interlinked structures including the Caid Residence; the *Médiathèque* and offices of CERKAS; and the Stara, a large area with several residences enclosed by defensive walls. The buildings and defensive walls of the kasbah were built primarily in rammed earth, with adobe bricks used for the construction of the upper parts of towers and cornices, particularly where decorative patterns enrich the facades. Oral history states that portions of Kasbah Taourirt were constructed beginning in the 17th century, though little fabric from that period remains. The majority of the kasbah dates from the late 19th century, when it became the residence of Si Hammadi el Glaoui, the representative in Taourirt of the Glaoui family who ruled all of Morocco from their stronghold at Telouet. In this period, Si Hammadi expanded the kasbah from an agglomeration of smaller buildings into a large defensive complex encircled by walls and complete with stables, servants quarters, workshops, a market, wells and *hamams*, and residences for his ten wives and numerous children. The Caid’s private residence, located in the northeast corner of the site, was richly decorated with painted ceilings and carved plasterwork on the interior, while wrought iron windows and Berber designs adorned the exterior.

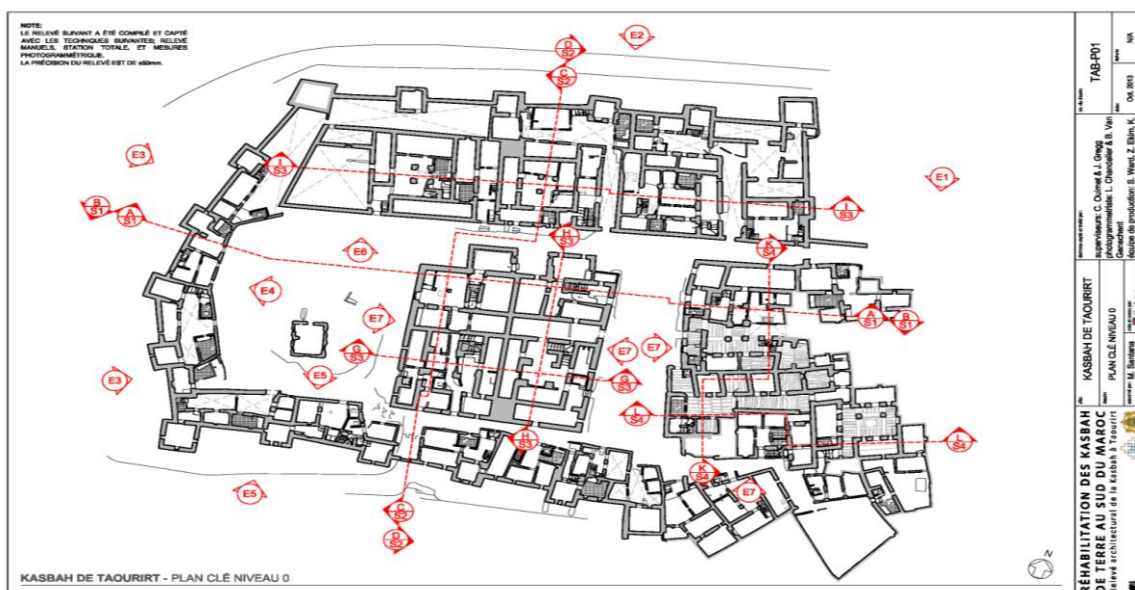
Figure 2 – Ground floor plan of the Stara sector of Kasbah Taourirt. GCI, 2013.

In order to develop accurate architectural drawings, a new survey of the kasbah was begun in 2012. Working with Carleton University's Immersive Media Studio, the GCI and CERKAS carried out a comprehensive survey of the kasbah and its various sectors (Fig. 2). The survey team employed Total Station and photogrammetry to develop a complete set of drawings including plans, sections and elevations of the kasbah as well as rectified photographic images of principal facades.

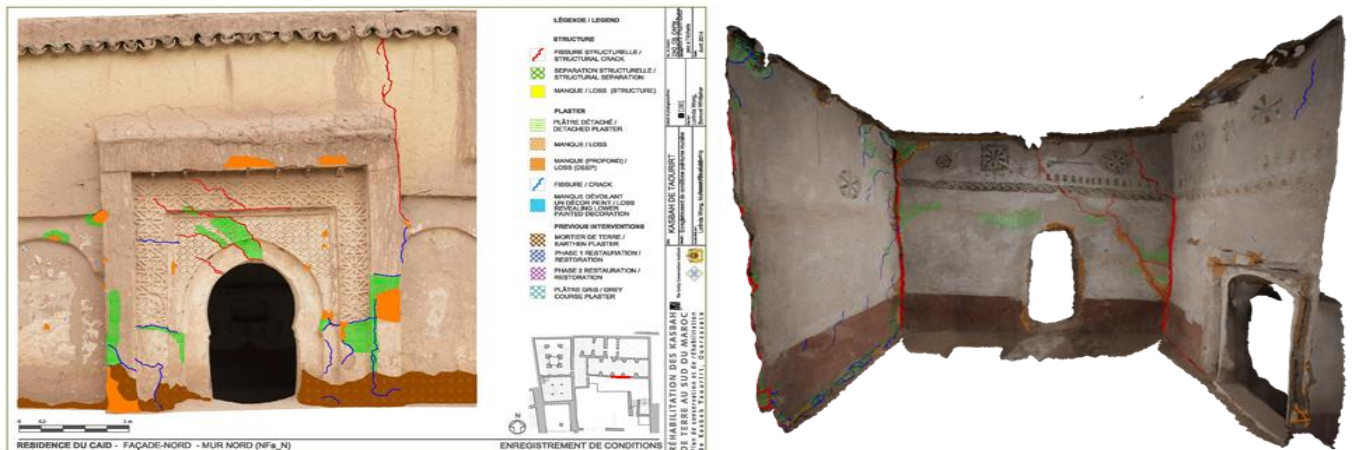
Figure 3 – Map of conditions in the Caid Residence (left), and 3D orthographic model of a painted room highlighting structural problems (right). Images: Lori Wong and Samuel Whittaker, 2014.

The assessment has revealed numerous phases of decoration, as well as threats to their survival, including major structural problems in supporting walls, failure of the roof, and large areas of detachment of the painting substrate. In parallel with the detailed assessment of wall paintings, an assessment of structural issues and roofing conditions has been carried out in the Caid Residence.

of the documentation, high resolution photographs of the decorated surfaces are taken and a photogrammetric model created from the images. Models are then exported to Meshlab, an open source software, to create orthographic photo elevations. These images are then scaled and arranged in AutoCAD, and printed for use as base images for mapping conditions such as cracks, detachment, and loss (Fig. 3, left).¹ 3D models can then be created to allow a virtual flythrough of the captured rooms and are useful for analyzing structural conditions and for showing the correlation between the architecture and areas of fragile decoration (Fig. 3, right). As part of this work, a glossary of conditions was developed to guide the assessment. Non-invasive examination techniques such as ultraviolet and infrared imaging, thermography, and microscopy were also used to study the layers of the paintings and their support.

The next phase of this work included the development and implementation of structural interventions that preserves the decorative surfaces intact. In preparation, emergency stabilization measures were undertaken on the painted decoration including grouting and edging repairs of delaminated plaster layers. Protection measures for the painted decoration were also implemented in one room to protect the paintings during construction work. Following the completion of the structural work on the building, conservation of the painted surfaces will need to be carried out.

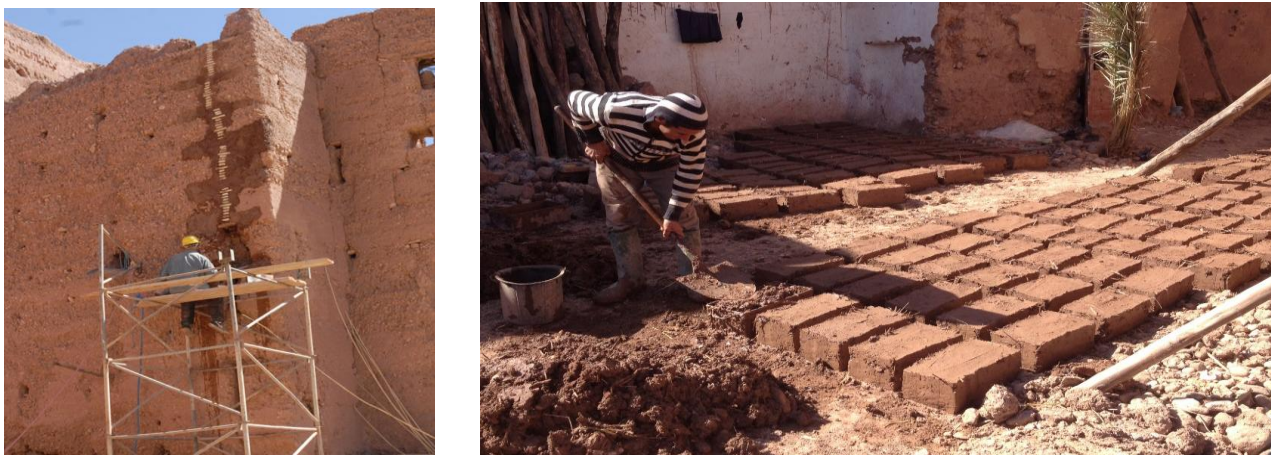
Figure 4 – Conservation works in the Stara, including repairing a structural crack (left), and preparation of adobe bricks (right). Photos: Benjamin Marcus, 2014.

The work in the Stara is reversing inappropriate alterations and re-establishing the traditional layout and form of the buildings, which was largely hidden under modern accretions. The restoration work is addressing priority conditions first such as replacing damaged roofs, repairing structural cracks and damaged walls, and eliminating moisture problems and basal erosion (Figure 4, left). This work is guided by the architectural drawings produced by the project as well as surveys carried out which identified new and historic construction.

A workshop has been established on site to facilitate the preparation of earthen materials including plaster, adobe bricks, and rammed earth (Fig 4, right). Roofing materials including wooden beams, reed matting and lime are also processed in the workshop. Local materials brought from the Ouarzazate area are being used in the rehabilitation and skilled craftsmen, known as *Maallem* in local dialect, are training laborers in traditional building crafts and techniques.
